MEDICAL REPORT OF THE *D. Bonner*  
JOINT COMMISSION FOR THE INVESTIGATION  
OF THE EFFECTS OF THE ATOMIC BOMB IN JAPAN  
VOLUME 6

Populations and Casualties  
(Sections 10M and 10N)  
Building and Shielding Studies  
(Sections 11M and 11N)

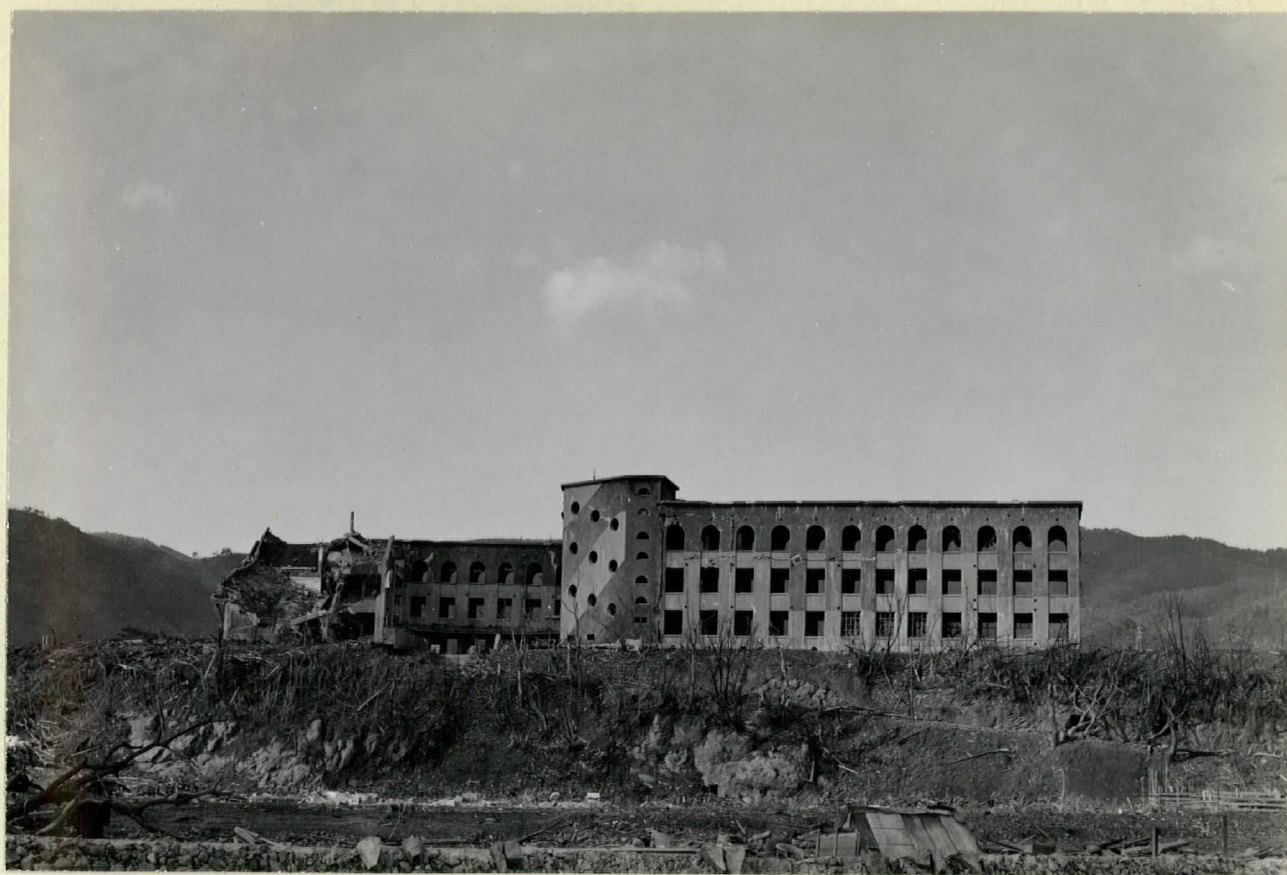
Figure 4 (11 N). Fuchi School, 1000 meters.  
Scene in the upper courtyard. The structure at the left is a re-  
inforced concrete fire-stairs which joined two wings of the wood-  
en buildings.

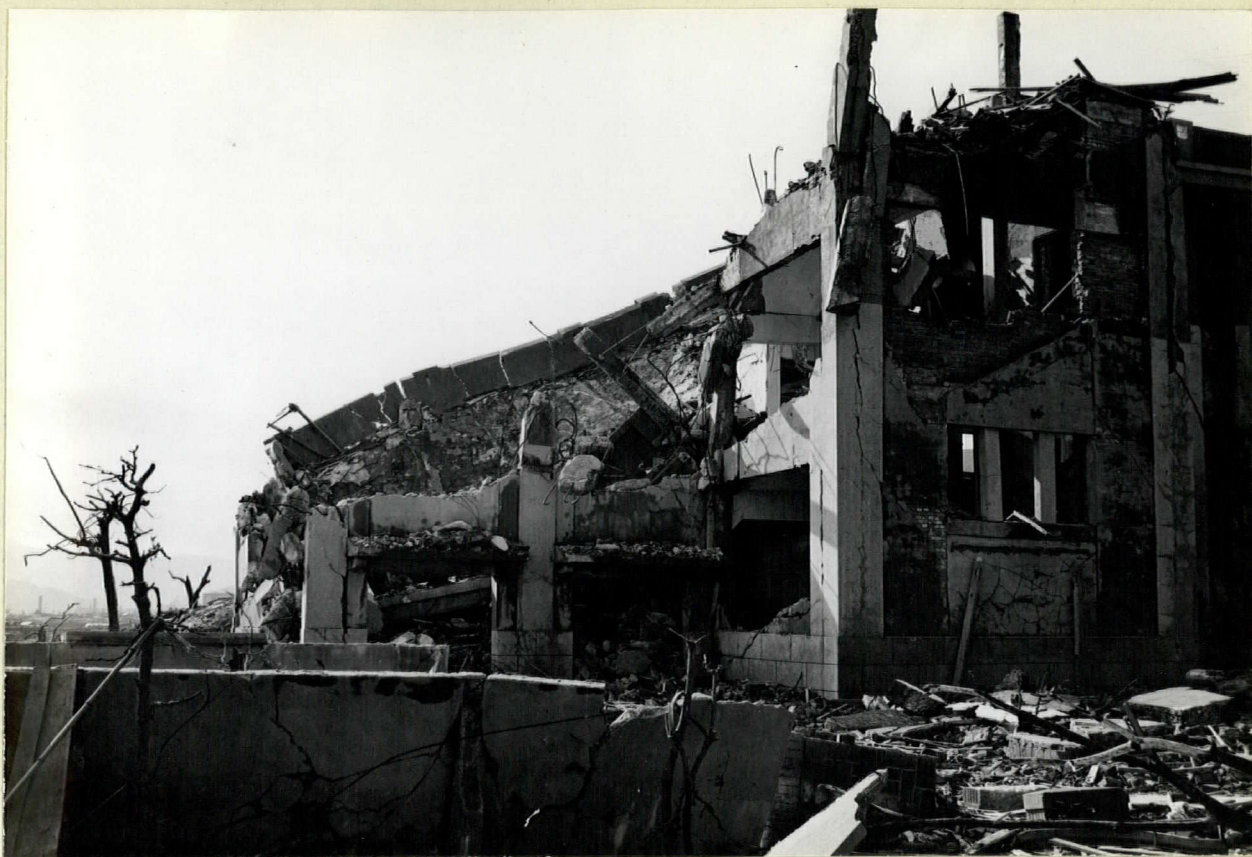
Figure 6 (11 N). Shiroyama National School.  
View of the main entrance. Notice the depression of the stone steps  
due to blast.

(2) Shiroyama National School is located on high ground, about 500 meters west of the center. (See Map, figure 1). It is a reinforced concrete building with walls 8 inches thick, and roof and floor slabs  $4\frac{1}{2}$  inches thick. The south wing is a recent addition, and was less strongly built than the remainder of the building. In Figures 5 and 6 the appearance of the damaged school is shown, with the roof of the south wing caved in by the blast. It is said (1) that this wing collapsed at some time (several hours) after the bombing; but the evidence for this is not available at present. During the war a part of the floor space of the school was devoted to war-manufactures. On 9 August, there were 151 people in and around the school, most of whom were workmen. The general location and the fate of these people is shown in (1) Report of the British Mission to Japan, classified.

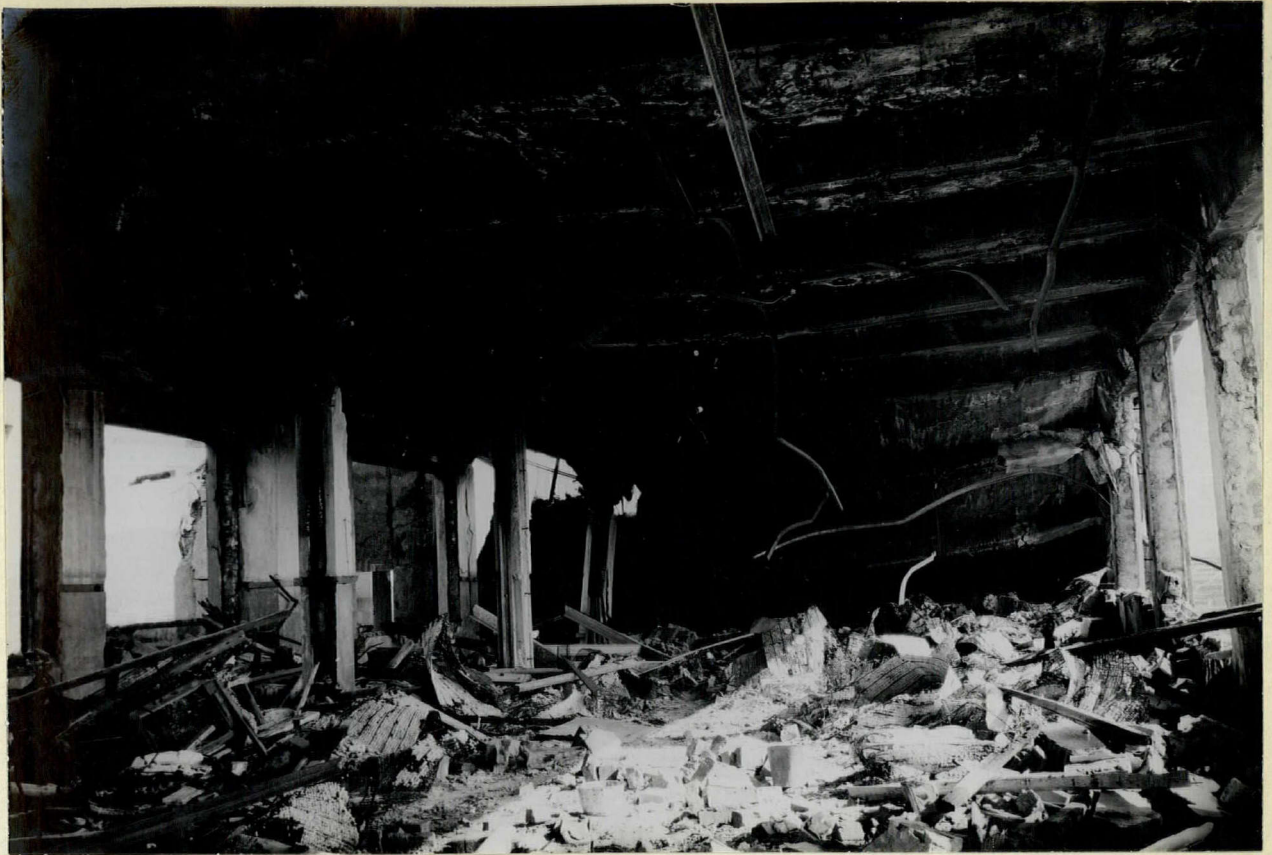
Figure 7 (11 N). Shiroyama National School, 500 meters.  
Close-up view of the South wing showing the collapse of the roof  
and the 3rd floor.

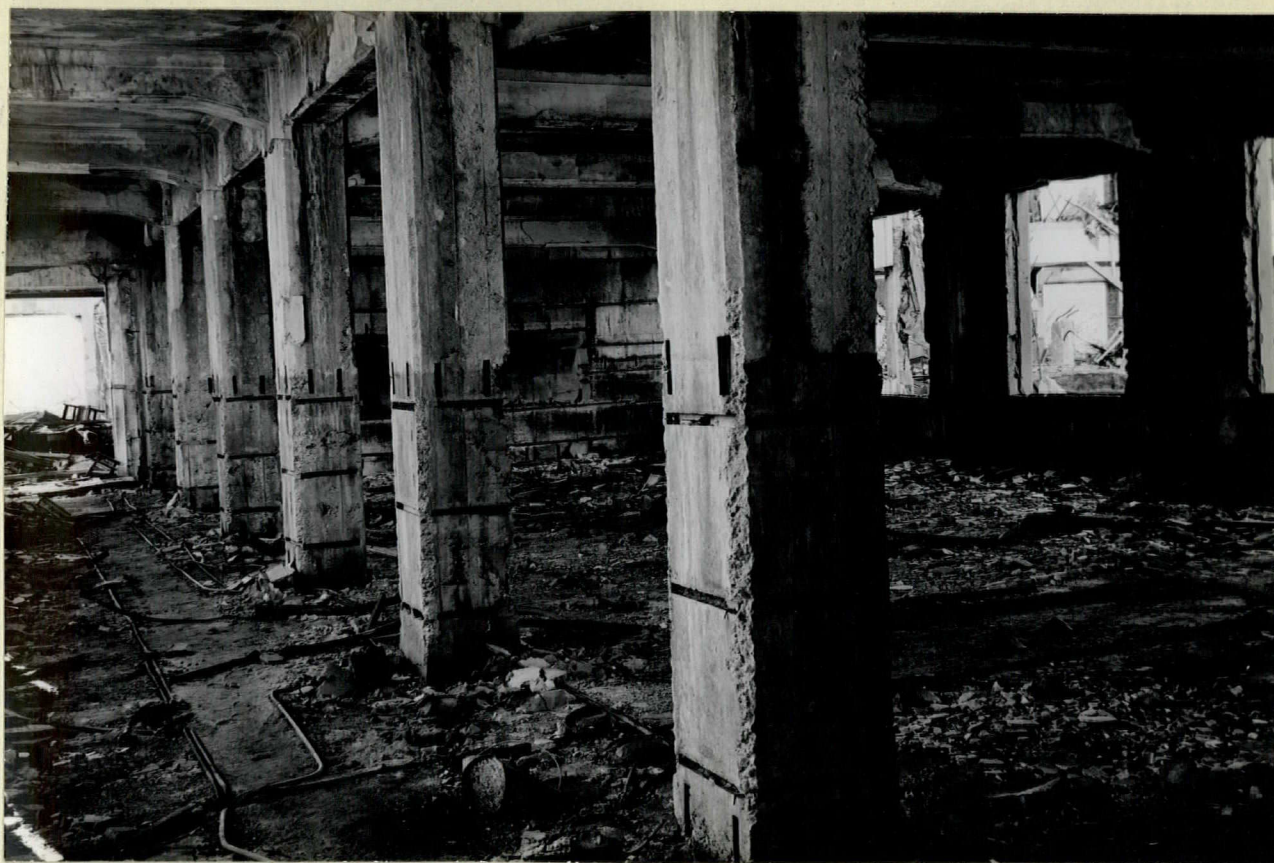
Figure 8 (11 N). Shiroyama National School, 500 meters.  
Interior view, 3rd floor of the south wing, showing the collapsed  
roof. There were no survivors among the 66 people who were on the  
3rd floor.

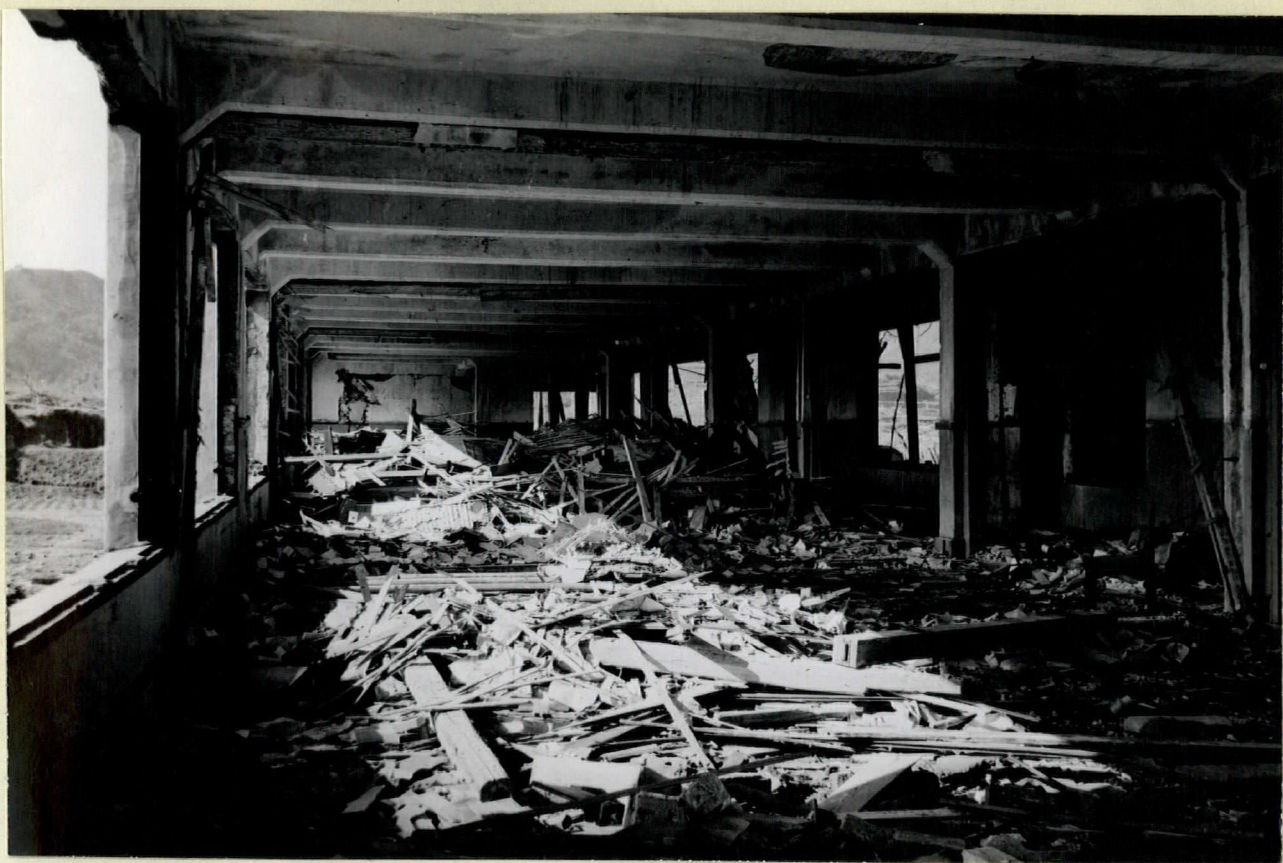
Figure 9 (11 N). Shiroyana National School, 500 meters.  
Interior view of second floor, west wing. There was only one  
survivor of the 7 people in this room.

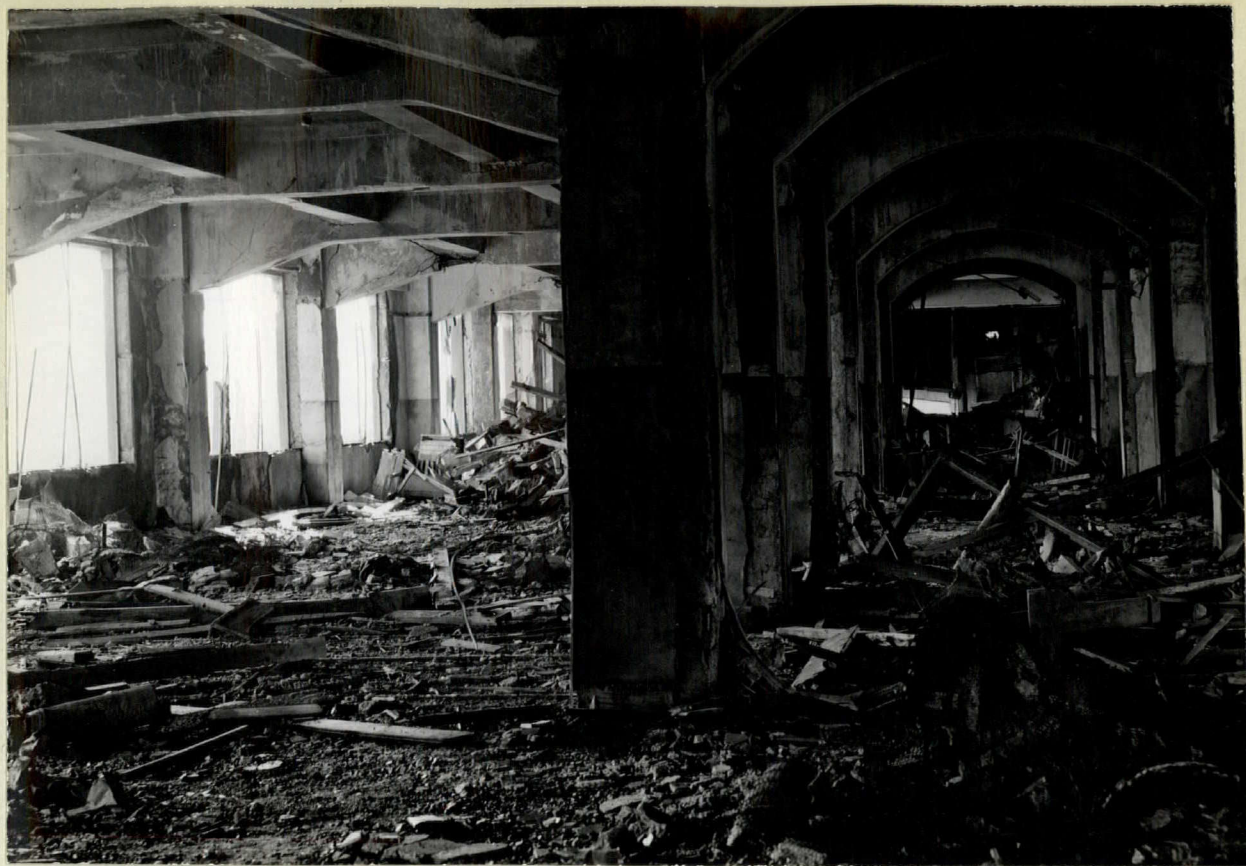
Figure 15 (11 N). Chinzei Middle School, 500 meters.  
Interior view, 4th floor, showing the depression of the roof. There  
were no survivors on this floor.

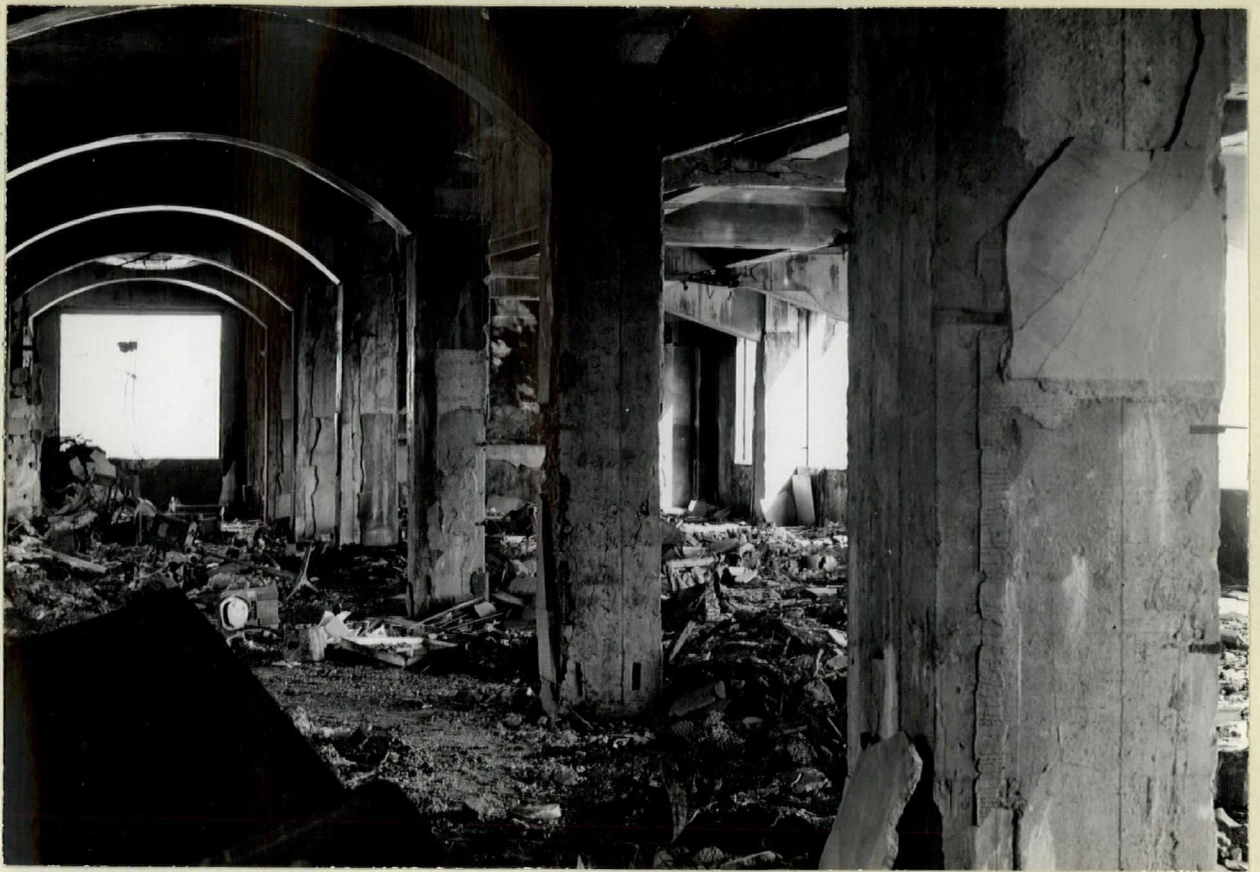
Figure 16 (11 N). Chinzei Middle School, 500 meters.  
Interior view, 3rd floor. This room was empty at the time of the  
bombing. There were, however, no survivors on other portions of  
this floor.

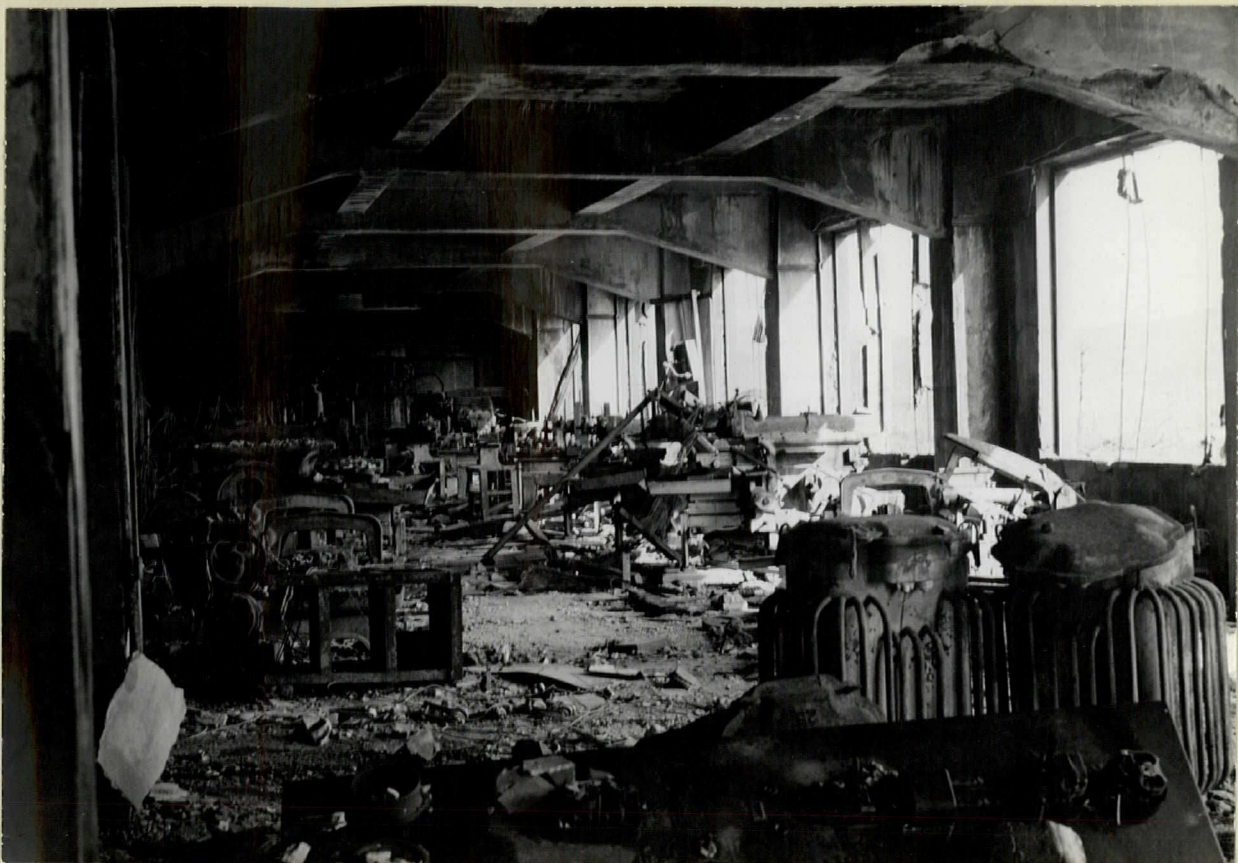
Figure 17 (11 N). Chinzei Middle School, 500 meters.  
Interior view, 2nd floor. Notice the heavy construction and the  
evidence of fire damage to the wooden structures which were stripped  
from the walls by the blast. All 36 persons in this section of the  
2nd floor died.
